### Water Quality for Bioluminescent Mangrove Lagoon in St. Croix, USVI

### Bernard Castillo II, Ph. D. & Kynoch Reale-Munroe

College of Science and Mathematics University of the Virgin Islands

### **Bioluminescence in SARI**

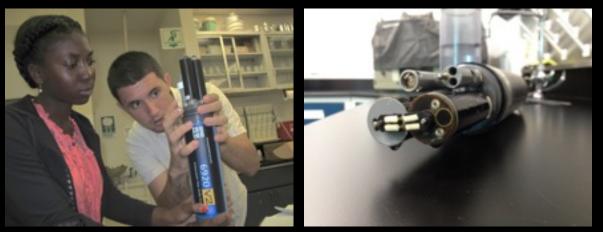
- In-situ Multi-parameter Water Quality Monitoring System (Sonde)
- Sonde: YSI 6920 V2
- pH, temperature (°C), Turbidity (NTU), Dissolved Oxygen (DO, mg L<sup>-1</sup>) and salinity (ppt)
- Programmed to log data in 1-hr intervals during the 1-yr study
- Total number of samples logged: n = 8,085
- Installed a weather station

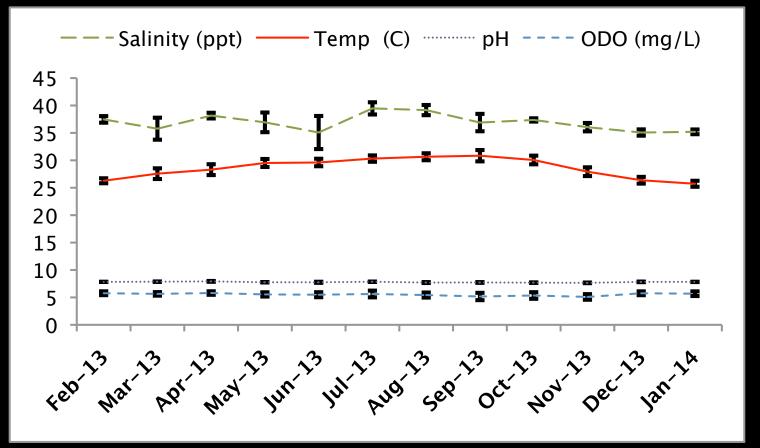
### Water Quality Averaged

#### Turbidity:

- · Some peaks associated with precipitation
- Data easily fouled

#### Salinity:

- Lower during rainy season
- Not always correlated with rainfall

#### Rain and Temperature:

Seasonal

#### **Dissolved Oxygen:**

- Normal diel pattern
- Rarely dropped below 4 mg/L

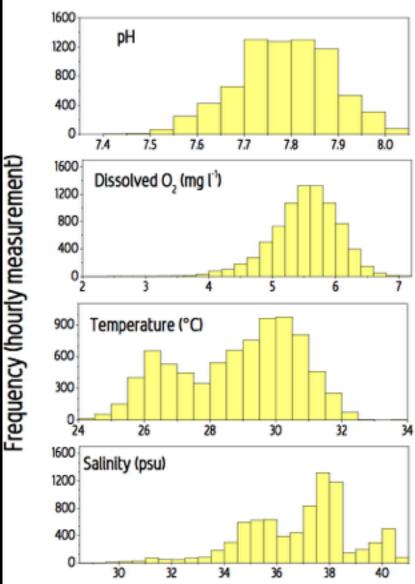
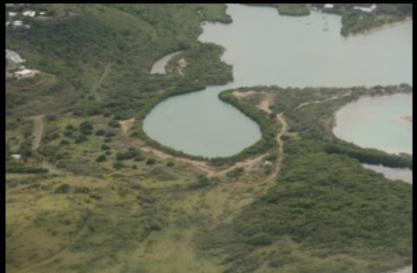
# Hourly Frequency

Parameter	Mean	SD	Min	Med	Max
рН	7.8	0.1	7.4	7.8	8.0
DO (mg L <sup>-1</sup> )	5.51	0.53	2.04	5.55	7.03
Temperatre (°C)	28.8	1.8	24.2	29.2	33.9
Salinity (ppt)	36.90	2.01	28.98	37.38	40.76

- pH had very little variation
- Temperature and Salinity exhibit seasonal clusters

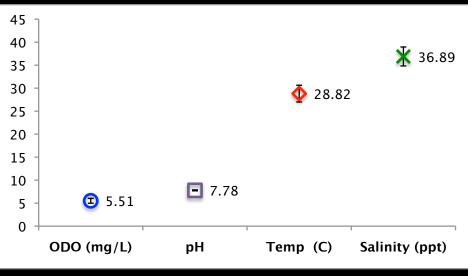
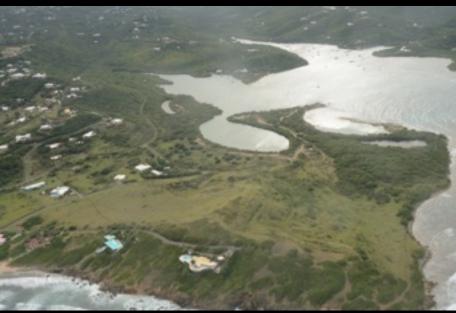
## VI Water Quality Regulations

- Salt River is Class B
- Temperature not to exceed 32 °C at any time
- DO not < 5.5 mg L<sup>-1</sup> from other natural conditions
- pH is 7.0-8.3 (tolerable limit)

Parameter	Mean	SD	Min	Med	Max
рН	7.8	0.1	7.4	7.8	8.0
DO (mg L <sup>-1</sup> )	5.51	0.53	2.04	5.55	7.03
Temperatre (°C)	28.8	1.8	24.2	29.2	33.9
Salinity (ppt)	36.90	2.01	28.98	37.38	40.76

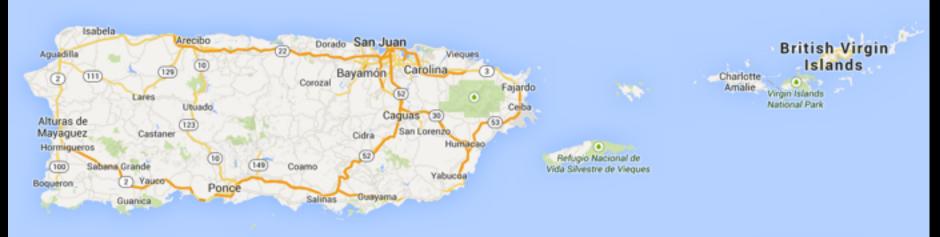
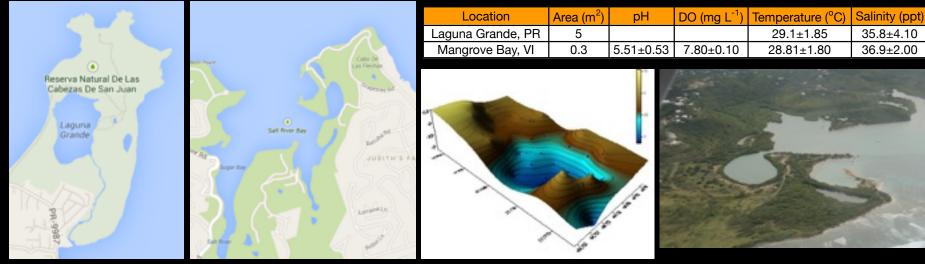
### Water Quality Comparison

35.8±4.10

36.9±2.00

- First bioluminescent bay characterized in US Virgin Islands
- Major contributor: Pyrodinium bahamense
- DO was slightly below VI regulation
- Temperature and pH were within regulation
- Water quality was comparable with Laguna Grande Bay
