**Environmental Education and Hands-on Training on Mangrove Restoration
Techniques at the University of the Virgin Islands Wetlands Reserve**

Project #2002VI1B

**Water Resources Research Institute
University of the Virgin Islands
St. Thomas, USVI 00802**

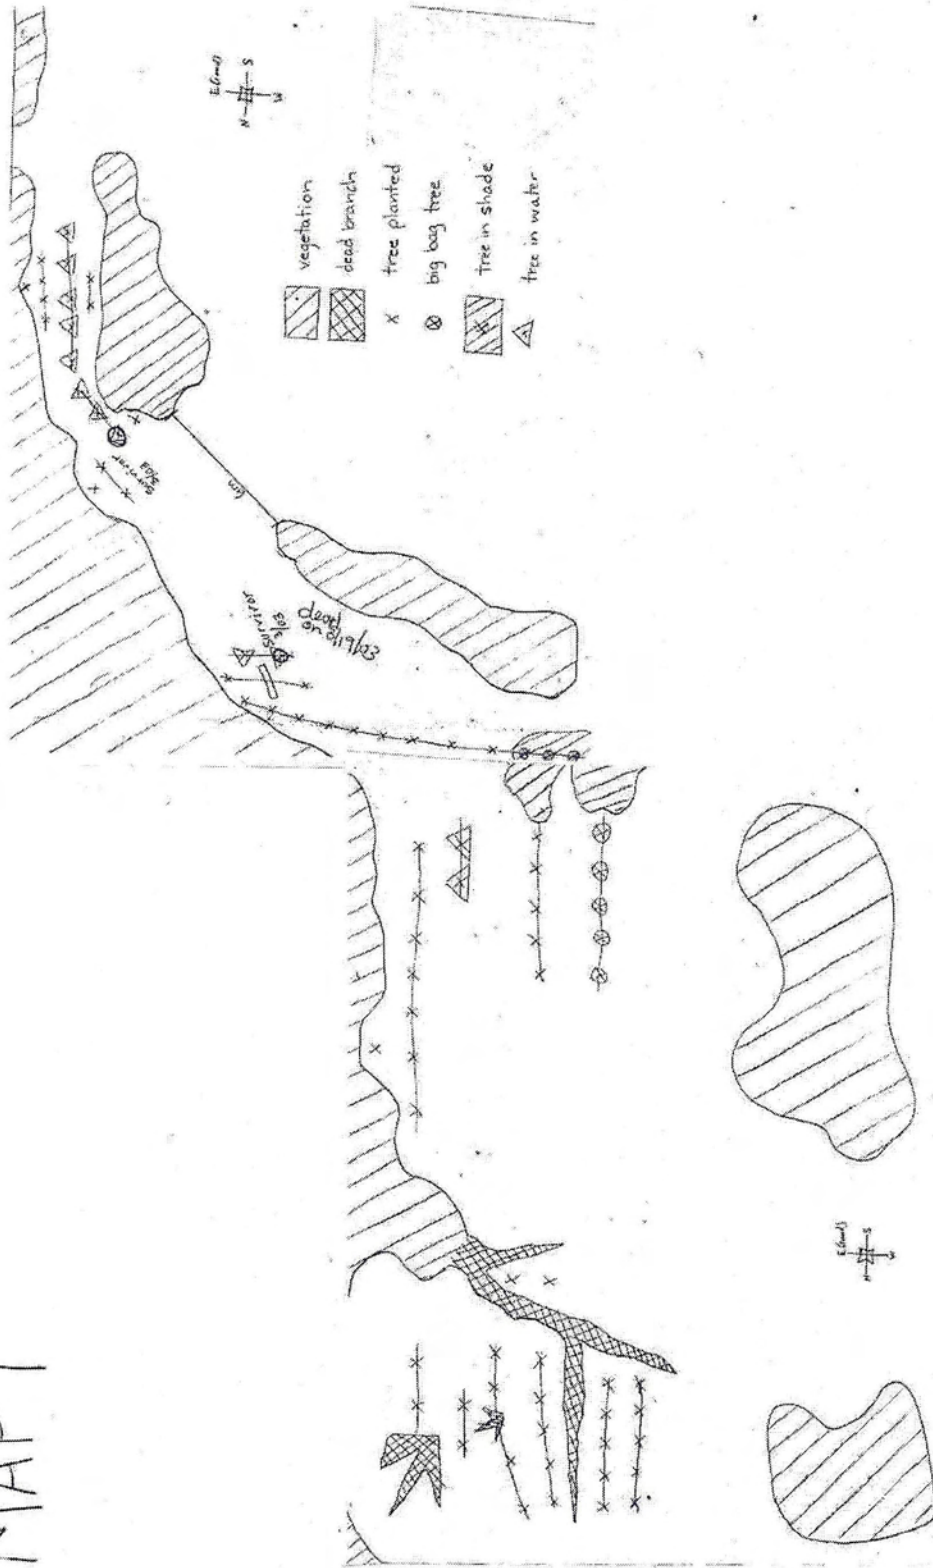
MAP 1

The 200 black mangrove (*Avicennia germinans*) seeds were collected during the summer of 2002, when they appeared to be ripe on the tree. Seeds were then germinated in tree cones using a mixture of mud from the site and Promix® media. The seeds were grown for 10 weeks before being planted. This method of germination was used instead of hand-broadcasting due to low survival rates (1-2%) of hand-broadcasted seeds (Lewis and Haines, 1981). The seedlings were watered using fresh water for the first 2 weeks, then 50% seawater, followed by 100 % seawater the last week before planting. After this time, the germination rate was low (<55%) so an additional 90 seeds were planted in a media composed of a higher percentage of Promix®. These seeds grew well and were put in the UVI greenhouse for several weeks (7/02-9/02). After the black mangrove seedlings were about 6 inches tall, they were removed from the greenhouse and exposed to a greater amount of sunlight in an attempt to “harden” them to full exposure (10/02). CMES staff and the student interns planted the black mangroves seedlings in December 2002 and January 2003. These seedlings were planted into the substrate on 1-meter centers landward of the high tide line (see Map 1).

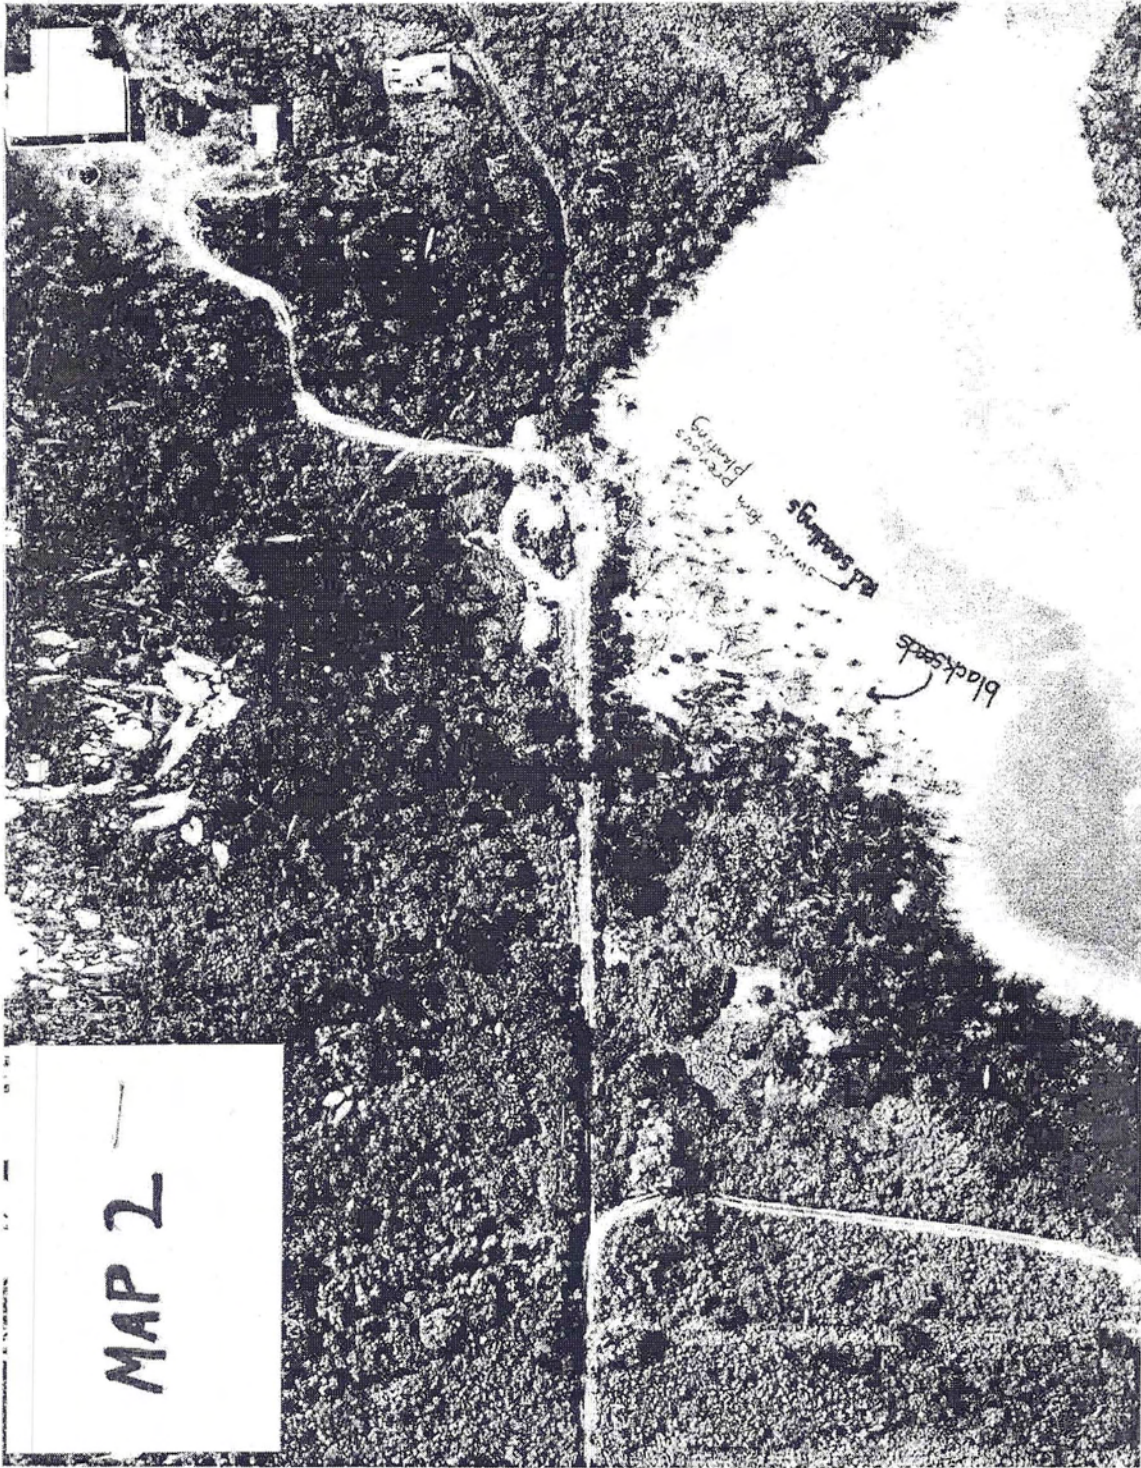
near the UVI Wetlands Reserve when it was determined that they were ripe. The CMES staff and student interns placed the black mangrove seeds on the surface of the substrate with no water cover at one foot intervals along 26 transects. All seeds were placed along the Eastern shore of East Pond (see Map 2). The 100 red mangrove propagules were planted in the former red mangrove planting area in about 4" of water in four transects parallel to the shore (see Map 2). Also noted was that as of this planting, only two black mangrove seedlings remain from the December and January plantings. Neither of the seedlings appeared to be especially healthy; both having wilted, brown leaves.
