# **EVALUATING THE SEDIMENT RETENTION FUNCTION OF SALT POND SYSTEMS IN THE U.S. VIRGIN ISLANDS**

February 16, 2006

Water Resources Research Institute  
University of the Virgin Islands  
St. Thomas, USVI 00802

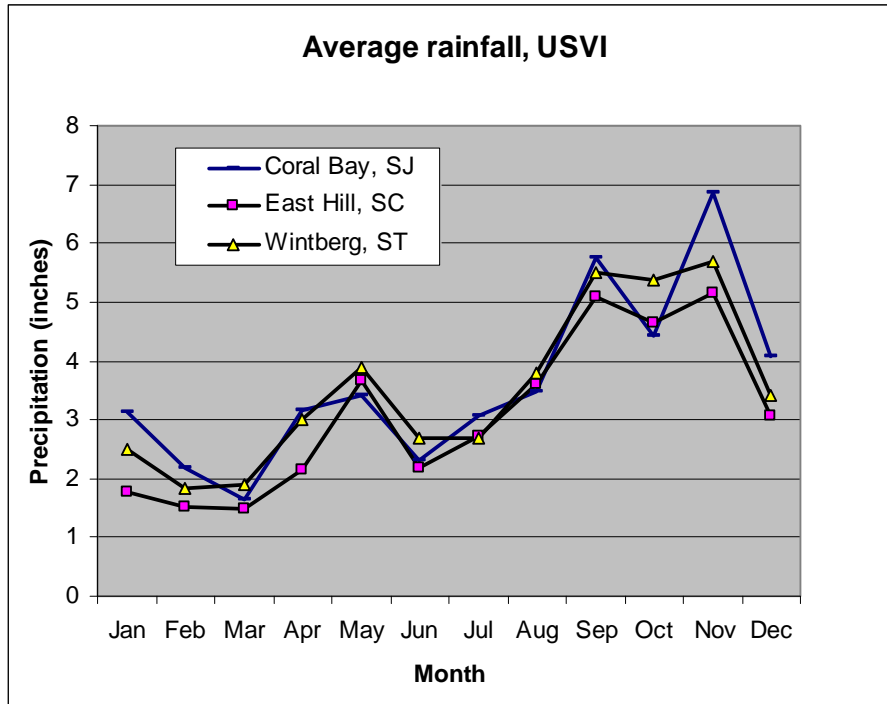
Figure 1. Average monthly rainfall (1972 – 2000)

Data from <ftp://ftp.wcc.nrcs.usda.gov/support/climate/wetlands/vi/>

Rain events on the three islands that exceeded 2.5 cm of rain in one day and major storm events in which daily rainfall exceeded 10 cm are shown in Table 3. Precipitation data for these events are listed in Appendix A.

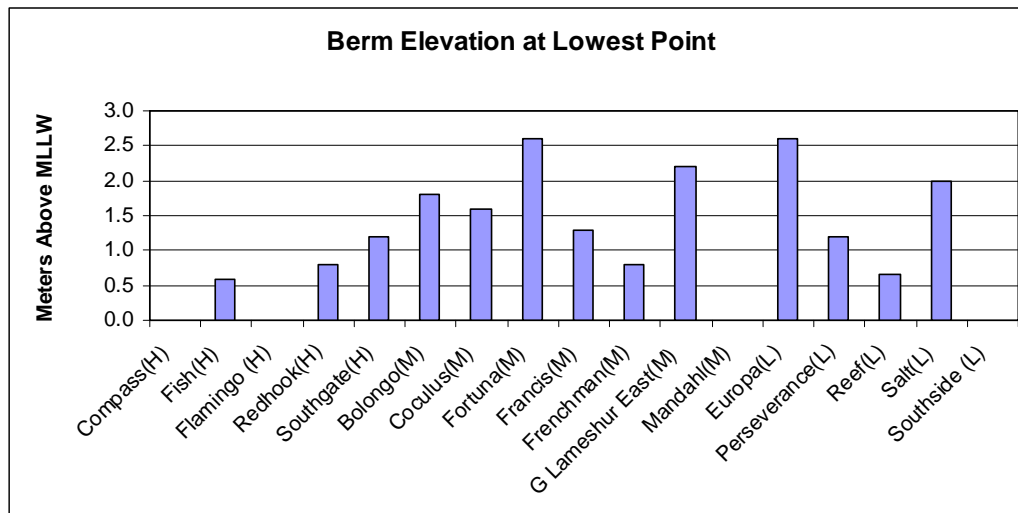
Figure 4. Berm elevation at lowest point

Low berm elevations may reflect low energy conditions that do not contribute to berm build-up or more frequent blow-outs or overtopping. Redhook and Frenchman ponds had no distinct channel leading from the pond to the berm so may fall into the former category. The lowest area of the berm fronting Reef Pond was at the mouth of a deep, man-made channel that led from the pond to the berm; channelized, land-derived flows with potentially higher velocities than would otherwise occur under natural conditions may contribute to hampering berm build-up at the channel mouth. This seems to be the case in the Southgate watershed where land-use activities and changes to the historical configuration of Southgate Pond appear to contribute to blow-outs of the beach berm (elevation not shown) from the East Gut (which lies to the east of the pond but is no longer part of the pond watershed) during storm events as reported by Gaines (2004). Similarly in the Fish Pond watershed, flows during rain events may occur more often or with greater velocity due to vegetation removal and road construction activity that has taken place in the watershed. This may be contributing to the relatively low berm elevation (i.e. more frequent blow-outs or overtopping) found at the mouth of the shallow channel that led from the pond to the berm.

**Berm substrate.** Berm substrates consist of cobble, coral, sand or a combination of these. No relationship to berm elevation is evident.

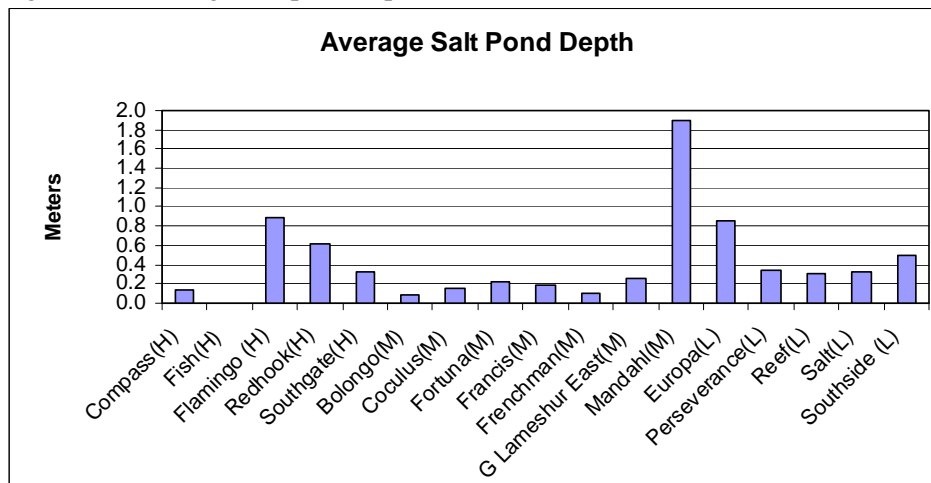
Figure 5. Average salt pond depth

In the USVI, storm events are often accompanied by strong winds, and sediment is less likely to become suspended in deeper ponds. In impounded ponds when the berm is not breached, resuspension of sediment within the pond is not considered problematic. In open ponds, such as Flamingo, Compass Point and to a lesser extent Mandahl which has been dredged more extensively, resuspended material from the shallow sections of the ponds has a greater chance of being exported to the sea.

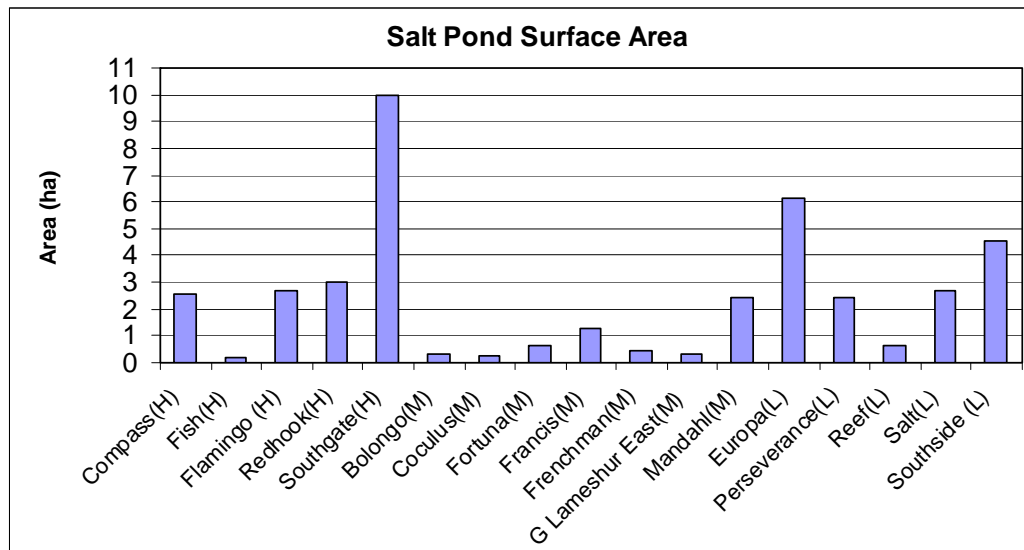
Figure 6. Pond surface area

Pond surface area. Depth of the pond may be a factor of its surface area. In 1994 surface areas ranged from 0.17 ha (Fish) to 10.0 ha (Southgate). Nine of the 17 salt ponds had a surface area greater than 2 ha (5 acres), and only Fish Pond was under 0.2 ha (0.5 acre). In general, the larger ponds are also the deeper ponds. Notable exceptions are Compass Point and Southgate, both of which appear to be much larger in relation to their depths.

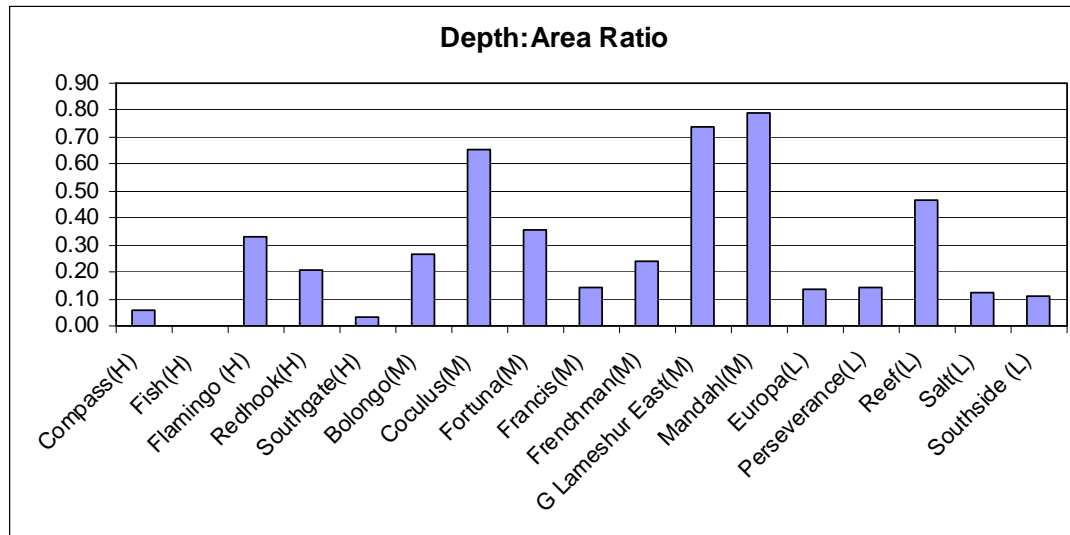
Figure 7. Pond depth: pond area ratio

Pond depth to surface area ratio. Ponds in general have a depth (m) to area (ha) ratio greater than 0.1:1 (Figure 7). The three exceptions are Compass Point Pond (0.06:1), Southgate Pond (0.03:1) and Fish Pond (dry), and these lower ratios may reflect elevated sediment inputs from their watersheds and a trend towards infilling. This is consistent with the findings of Brooks *et al.* (2004) who noted an increase in sediment accumulation in Compass Point and Fish ponds and with the observations of Gaines and Crawford (2004) and Gladfelter and Gaines (2004) on the reduction in size of Southgate Pond due to possible infilling and other modifications in the watershed. Since pond surface area is a fixed calculation based on full pond level, the ratio will vary based on when depth sampling occurs.

- Pond depth appears to be related to pond surface area with the larger ponds also being the deepest.
- The ratio of pond depth to surface area appears to be a good indicator for identifying a potentially impacted condition.

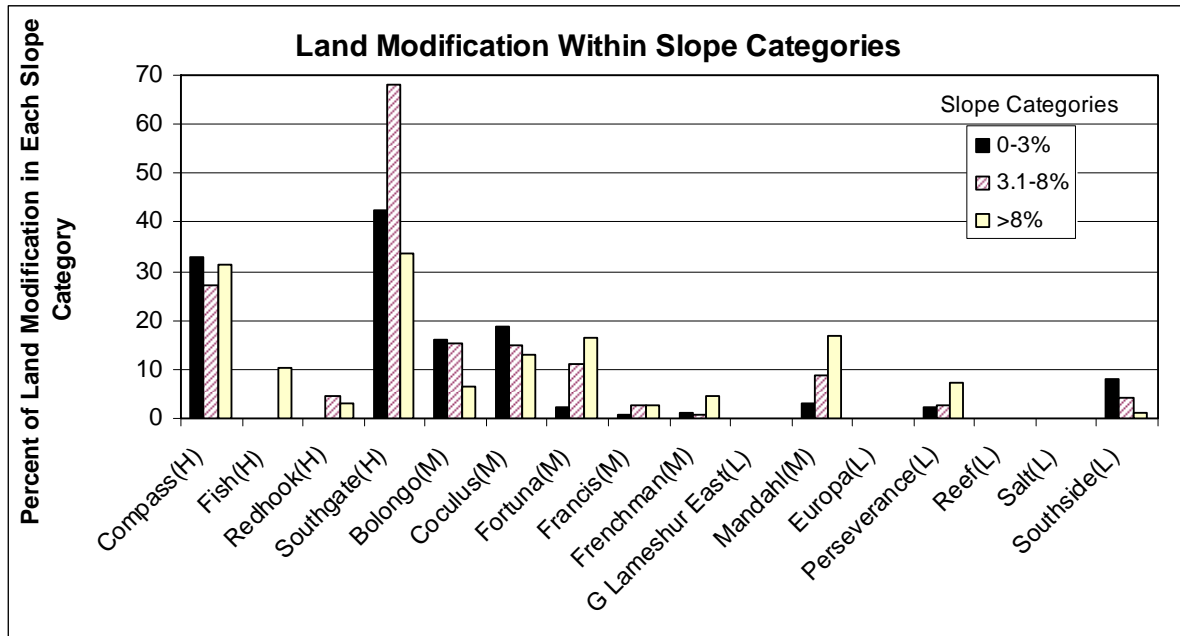
Figure 15. Land modification within slope categories.

Land modification was found across all slope categories (Figure 15). Where removal of the natural vegetation communities is taking place on steep gradients, disturbed soils will be subject to higher flow velocities and a greater potential for being transported to the lower watershed. Pond watersheds where land modification exceeded 25% of the land area within gradients greater than 8% were Compass Point and Southgate. Pond watersheds where land modification exceeded 10% of these steeper slopes included Fortuna, Coculus and Mandahl on St. Thomas and Fish on St. John.

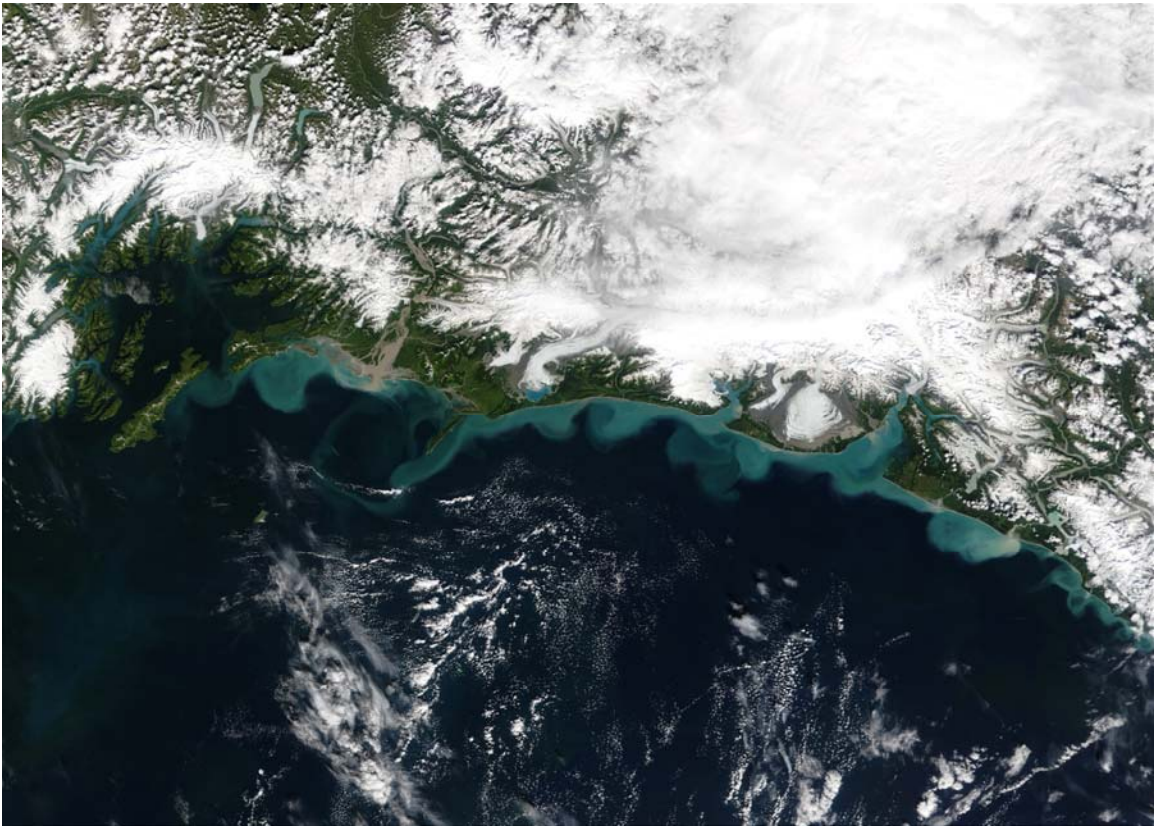
Figure 25. MODIS image of the Copper River (Moderate Resolution Imaging Spectroradiometer) discharging sediment into the Gulf of Alaska. August 22, 2003

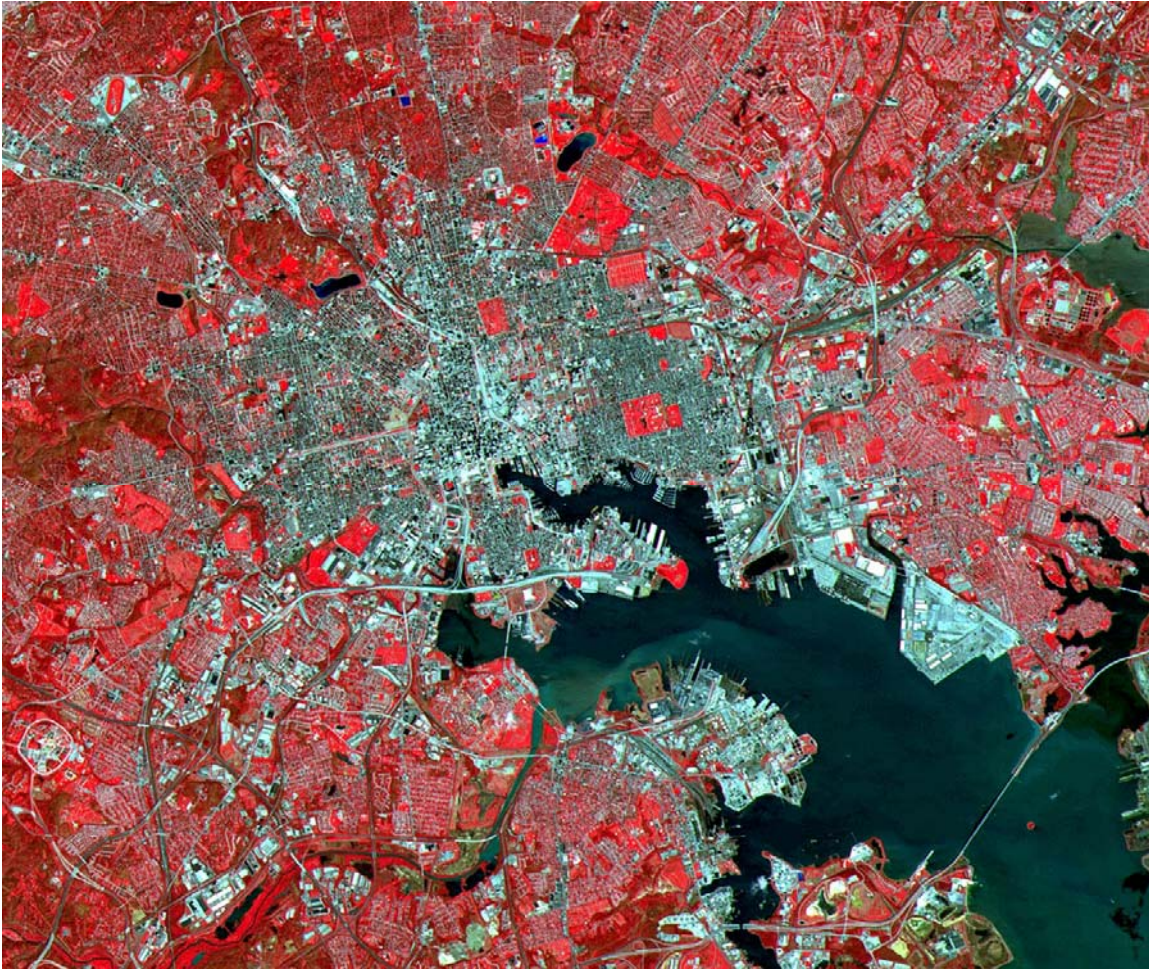
Figure 26. ASTER image of Baltimore, Maryland (Advanced Spaceborne Thermal Emission and Reflection Radiometer), April 4, 2000. Sediment in the water column in Baltimore Harbor is evident as it disperses from the river running from the bottom left corner to the south side of the harbor.

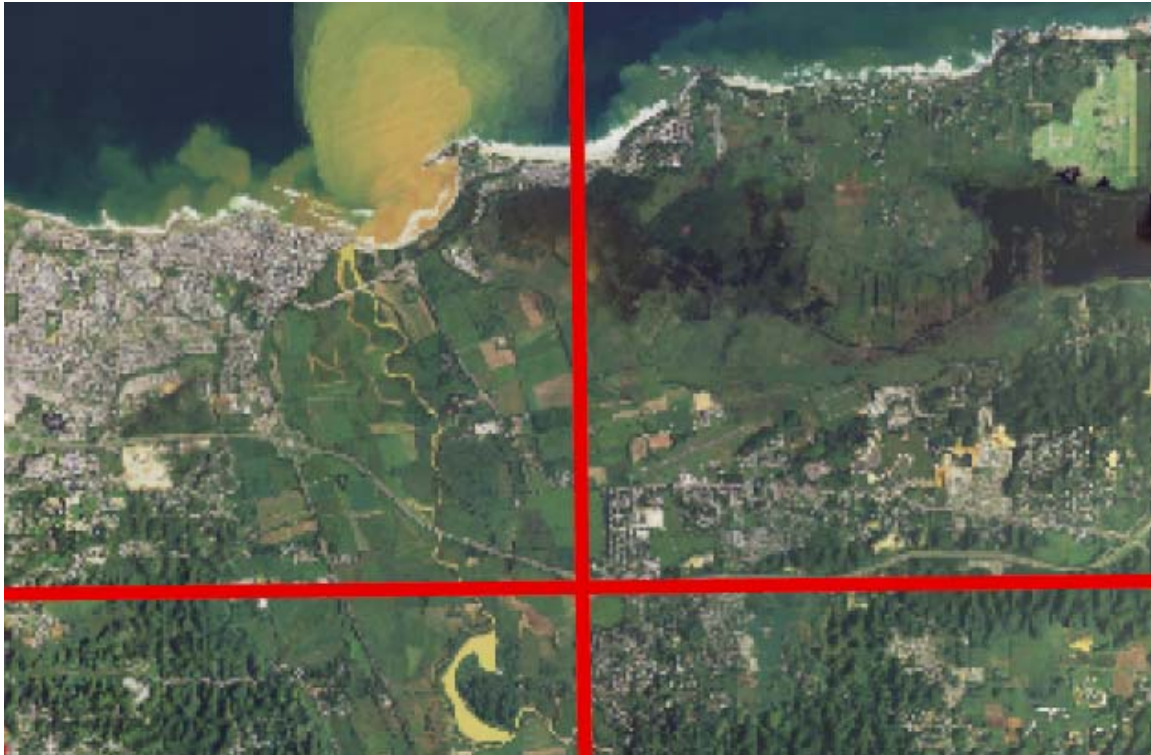
Figure 27. Northwestern coast of Puerto Rico, Arcibo, Rio Grande de Arcibo. September 21, 2004. Sediment is evident in the Rio Grande de Arcibo itself and a sediment plume is evident at the mouth of the river in the nearshore waters.

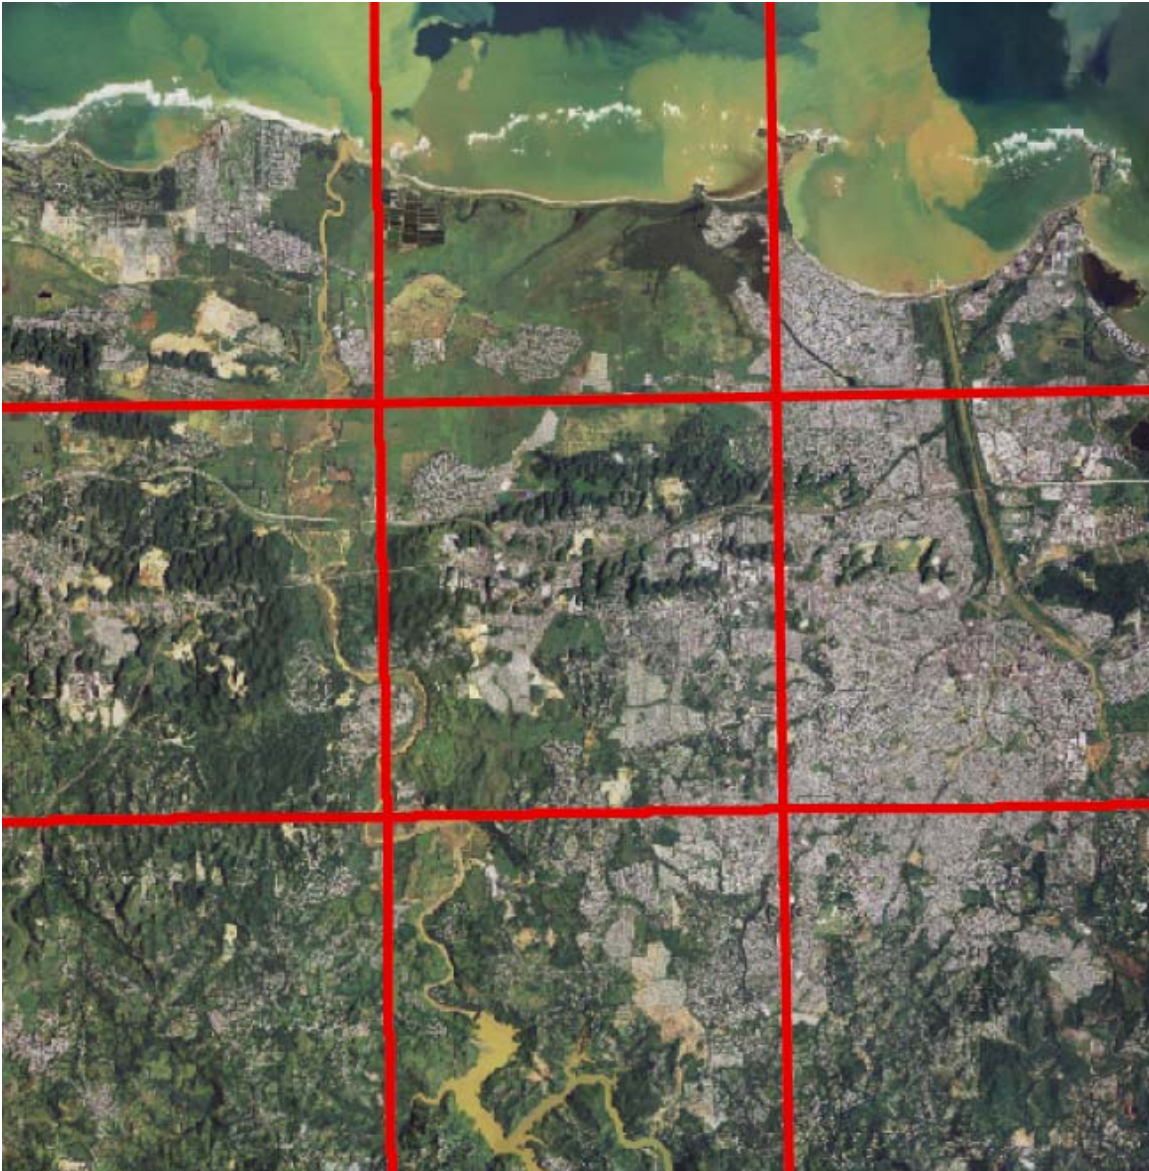
Figure 28. North central coast of Puerto Rico, San Juan area. September 21, 2004. West -- Rio de la Plata, East -- Rio de la Bayamon. Sediment plumes are evident at the mouths of both rivers.

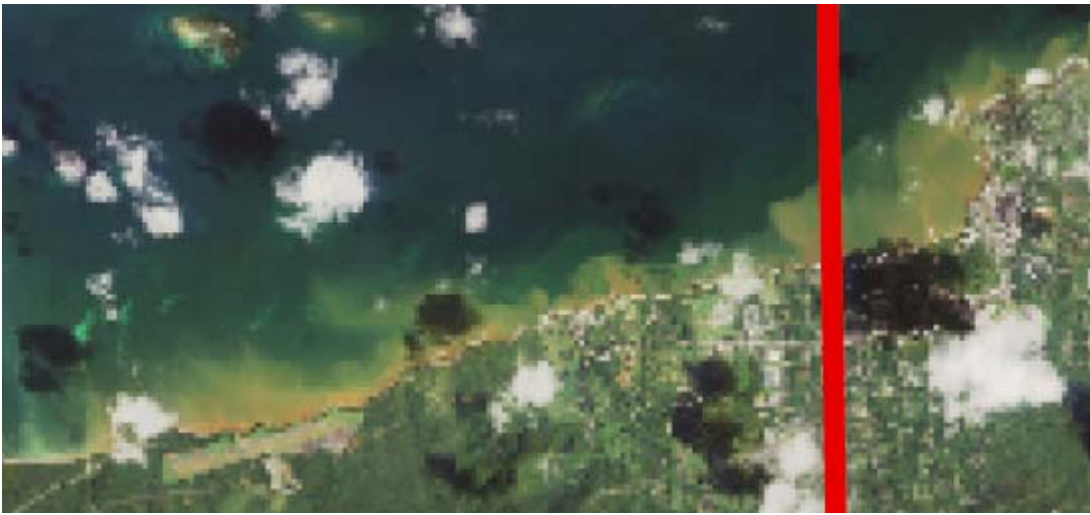
Figure 29. Northshore of Vieques. September 21, 2004. In the lower left is the Aeropuerto de Vieques, in the upper right is the town of Isabel Segunda. Suspended sediment in the water column is evident along much of the depicted coastline.

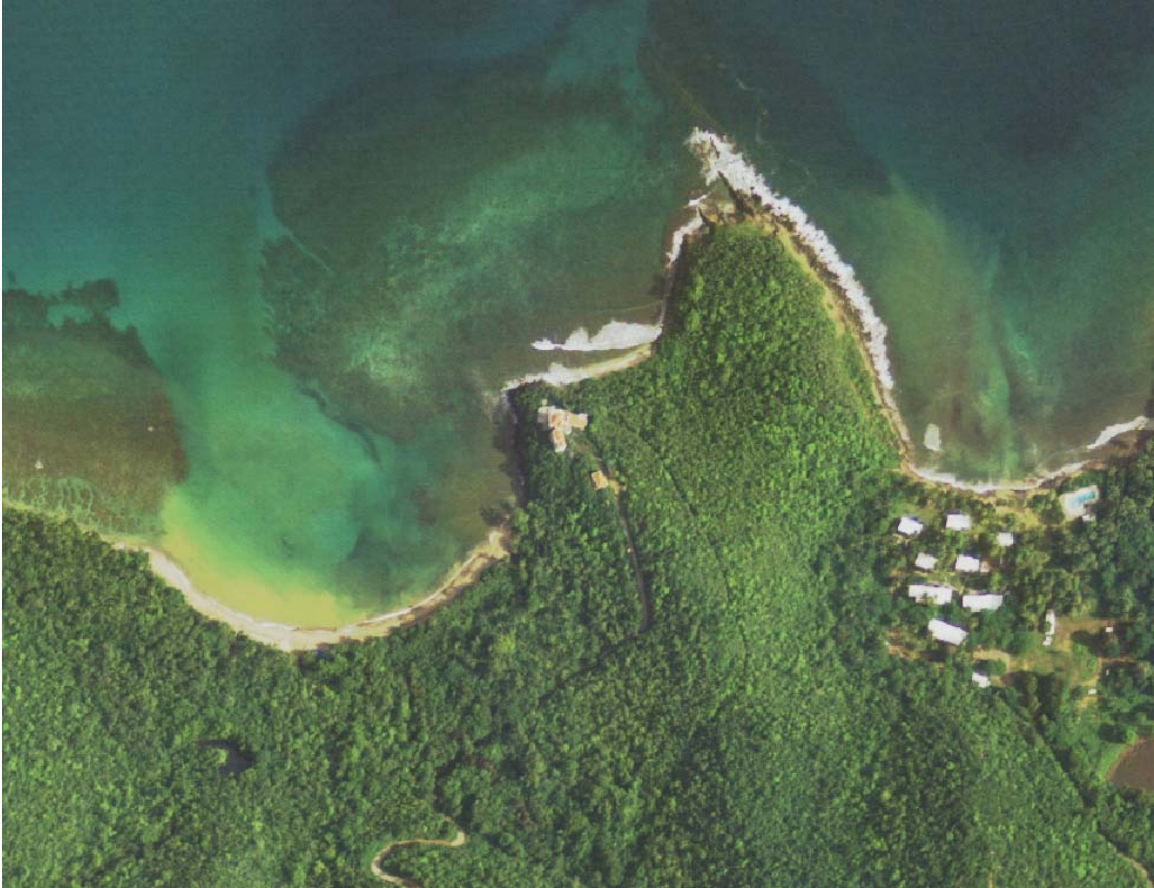
Figure 30. Neltjeberg Bay, north coast of St Thomas, USVI. September 21, 2004. The yellowish band immediately off the beach is a sediment plume.
